Summary of a Technical Validation of ENERCON's Rotor Blade De-Icing System

Project-No.: VC10019

Report-No.: PP11035, Version 2

Date: 2011-09-22

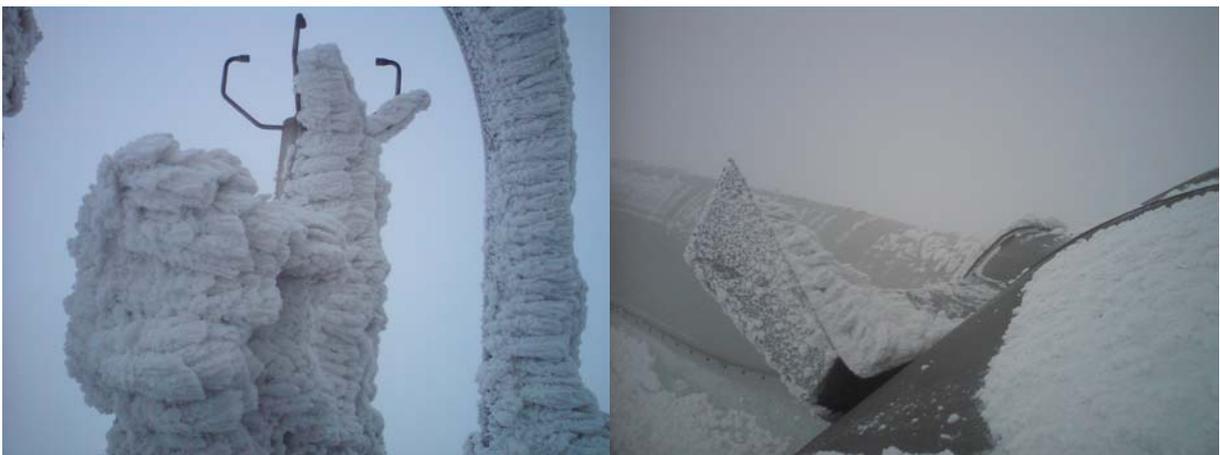
Figure 6: example of extreme icing conditions at the wind farm Krystofovy-Hamry, left: nacelle anemometer and air temperature sensor of a test WEC on 2010-01-14 14:45, right: heated rotor blade of a test WEC at the wind farm Krystofovy-Hamry on 2010-01-15 12:26

A photographic analysis of the performance of the rotor blade de-icing system showing the outside of the rotor blade proved the absence of ice on the critical sections of the rotor blade, having only minor icing on the trailing edge of the rotor blade remaining (Figure 5). Only at very harsh icing conditions, the system is unable to de-ice the rotor (Figure 6).
