# Glycerol-based hydraulic fluid for hydropower industry

*Yijun Shi (project leader)*

*Luleå University of Technology, 971 87 Luleå, [yijun.shi@ltu.se](mailto:yijun.shi@ltu.se)*

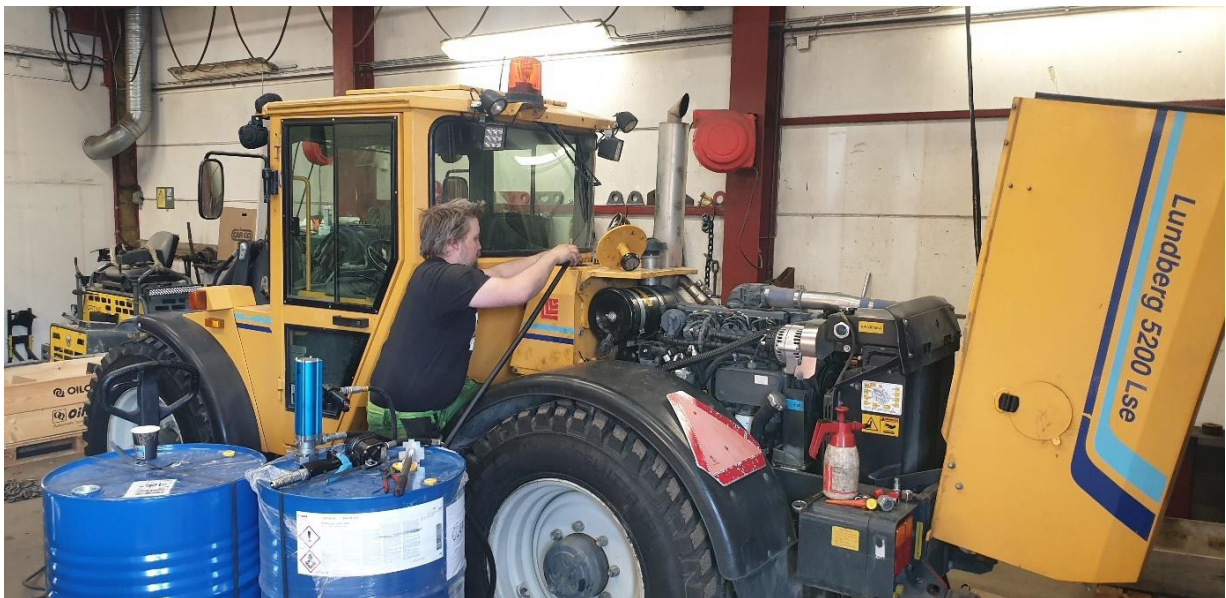
Fig 1. Leif is filling the first batch of flushing fluid in the hydraulic tank.

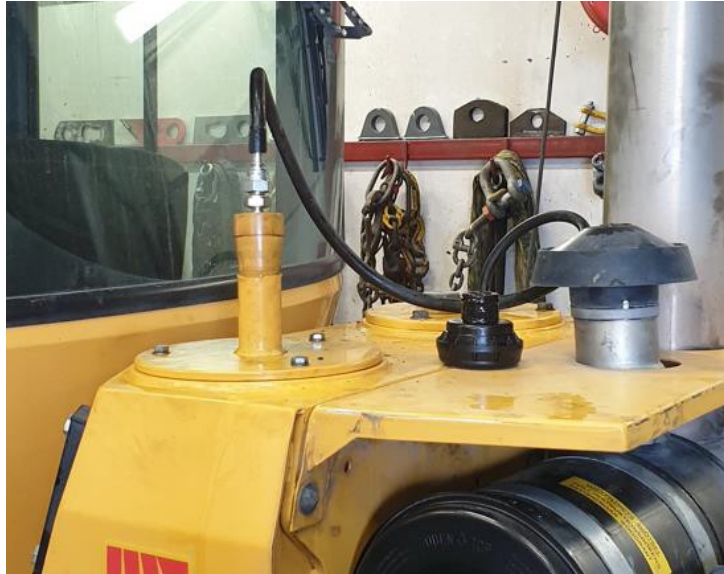
Fig 2. The air pump was pressed onto the tank and hold when running to make sure the pumps were not running dry during the first start-up.

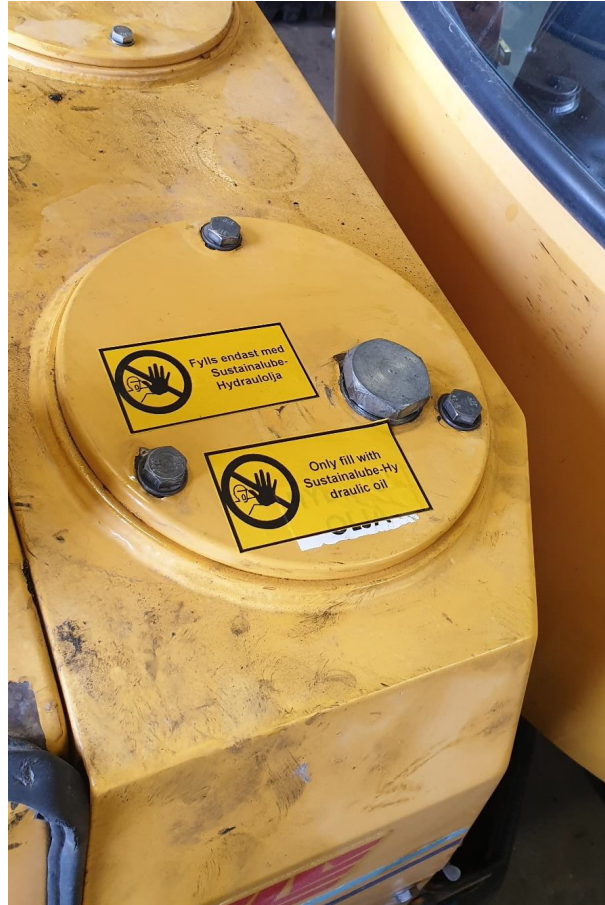
Fig 4. Hydraulic fluid tank with warning decals on, also wrong notion here with “oil” but the message should be clear: Only use Sustainalube

- (12) Now fill the system properly with the hydraulic fluid.
- (13) Later on, the mechanic said he was going to change the oil filter the next day.
- (14) Two stickers were placed on the fluid tank so that no one should fill it with another fluid by mistake (Fig. 4).

Here the notion is wrong as Sustainalubes hydraulic fluid should not be considered as an oil, but the mechanic was determined that otherwise the operators might not understand the message.

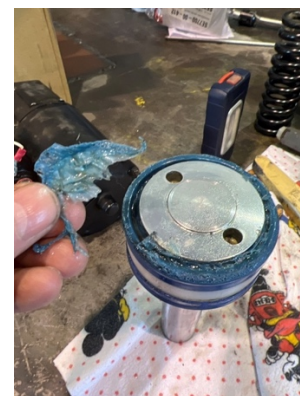
Figure 2, Broken seal on brake cylinder.

The samples of hydraulic fluid (1) after filling into the machine; (2) after around 4 months running with around 550 hours real running hours, were taken, and will be analyzed. Due to the damaged sealing material (Figure 5 and Figure 6), the test is stopped after around 18 months trying.

analysis. The full report from Danfoss is attached. In summary: None of the parts showed any signs of immediate failure, but all the moving parts (piston ball slipper or the valve) showed some sticky behavior and were difficult to move. The valve segment cylinder block interface of the motor exhibits evidence of high-temperature generation. However, in the raceway predominantly polishing wear was observed only. The endcap valve segment interface exhibits adhesive wear, which has a negative influence on the performance of the motor. It is difficult to judge whether this was caused by the long period of storage and subsequent cleaning of the parts, or whether it occurred during operation.

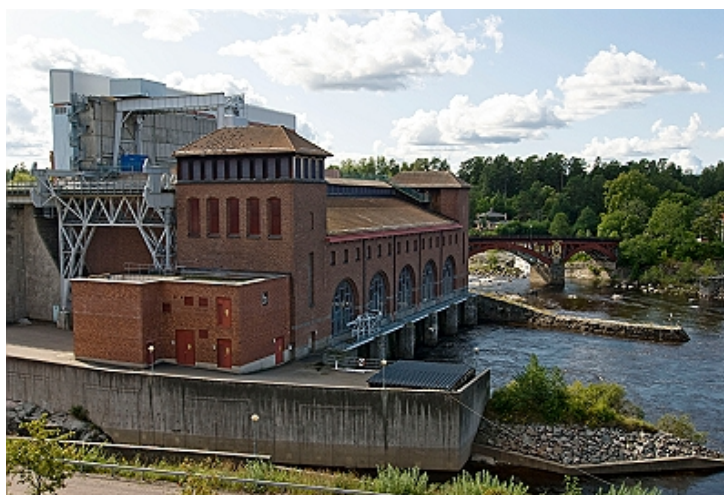
Fig.7 The field test place in Vattenfall at Älvkarleby.

Under the financial support by previous Håva project funded by Energimyndigheten (Håva, Dnr 2018-003910), a field test has been started in Vattenfall R&D center in Älvkarleby since 2021.07 until now. Since Vattenfall is so happy with the performance, Vattenfall changed another hydraulic system which they bought in the summer of 2022 into our glycerol-based hydraulic in 2022-09-29. Two hydraulic systems are keep running under a temperature of around 50 to 60 °C and working pressure from 180 bar to 250 bar until now. Before Christmas in 2023, it was found that one valve was damaged. We will continue the test for at least one more year. We sent the damaged valve to the supplier (HYDAC) in Germany for analysis. In summary, the cause of the fault is salt-like deposits that have been flushed in through the side inlet holes. The deposits led to scoring in the valve body, causing the piston to jam.

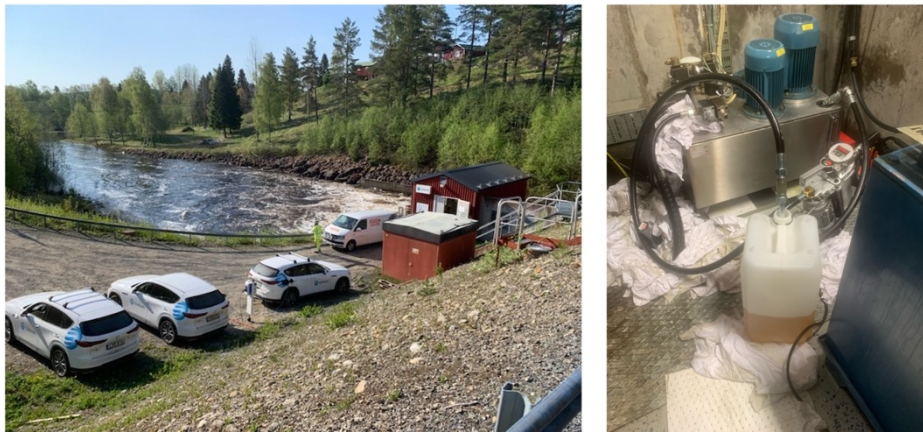
Fig. 8 The field test in Statkraft, Nyfors from 2023.05 until now

field tests have been started in Statkraft: one is in Nyfors from 2023.05 until now and another one in Skeen from 2023.09. The people at Statkraft are quite satisfied and happy with the performance until now. Not any issue has been found. We will continue the test for at least one more year.

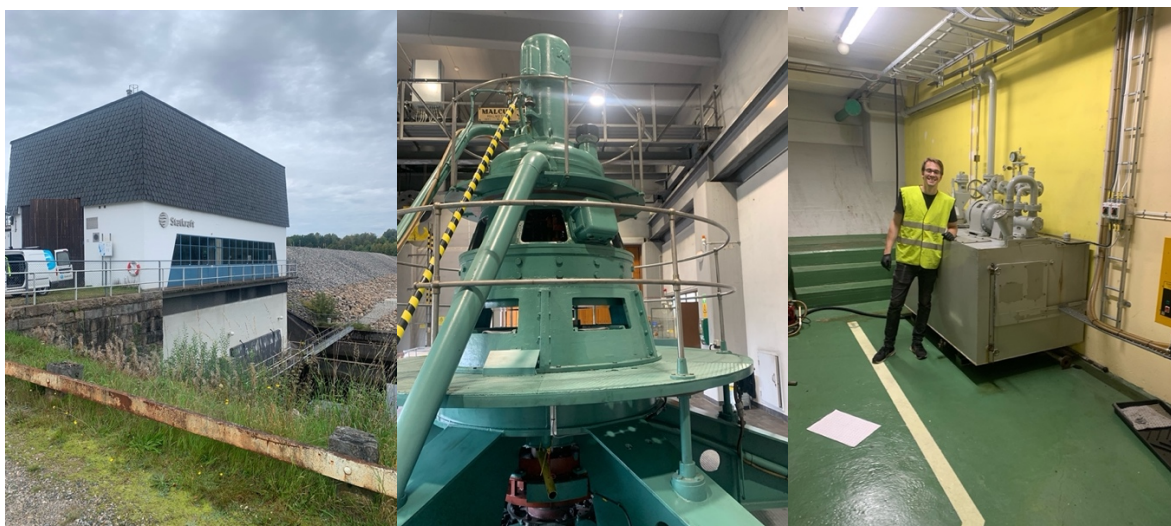
Fig. 9 The field test in Statkraft, Skeen from 2023.09 until now

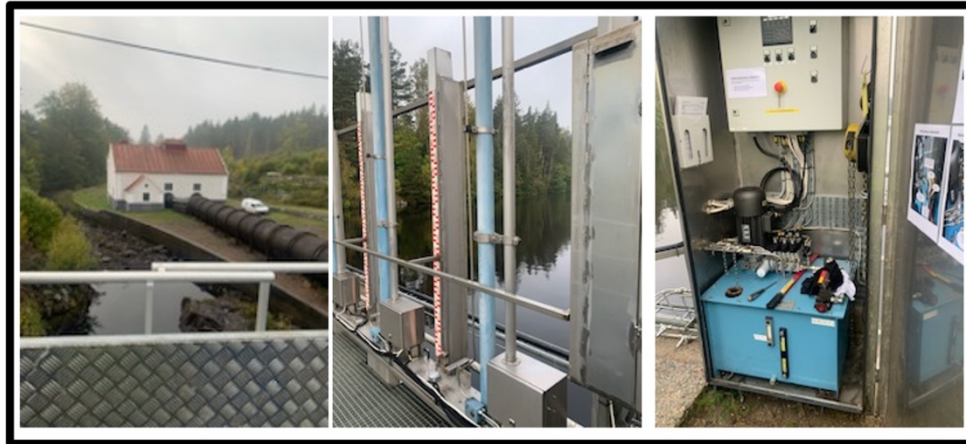
**Hydraulic system for water outlet**

Figure 10 The field test at Verperyd, Uniper.

Based on the successful field test experience in Vattenfall and Statkraft. We started one field test in Verperyd Uniper in 2023.11, which is a hydraulic system for flood gate control with a tank size of 100 liters and runs under room temperature. After around one month's test, the people at Statkraft found that (1) a small part of the paint inside the hydraulic tank was damaged; (2) the pressure went up from around 80 bar to around 150 bar which goes up to their system's alarming level. After a careful discussion and investigation between LTU and Uniper, we believe that the paint damage should be due to the left cleaning fluid in the system, and the higher pressure should be caused by the lower temperature (went down to -10 °C at the middle of December from around 10 °C when started the

test). The viscosity of the hydraulic fluid was increased too much when the temperature was decreased. Based on the discussion, Uniper replaced the old tank with a new stainless tank. At the same time, we at LTU provided a new hydraulic fluid with lower viscosity at lower temperatures. We changed the hydraulic tank and the hydraulic fluid during Christmas time. It was found that the system ran very well after the change, the pressure went down from 80-150 bar to around 40 bar. Since then no technical problem has been found. The Uniper people are very happy with the situation now!

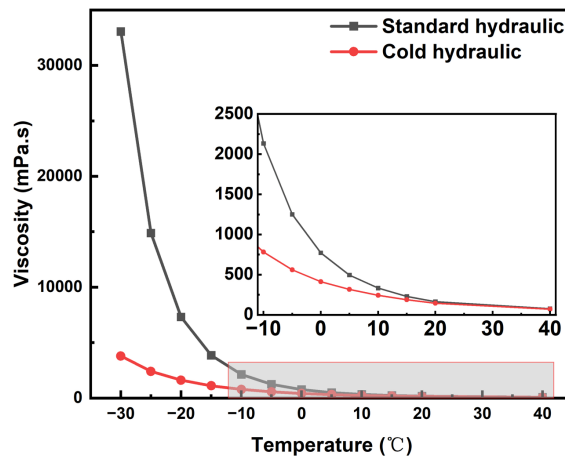
Figure 11 The viscosity of the new hydraulic fluid under different temperatures.

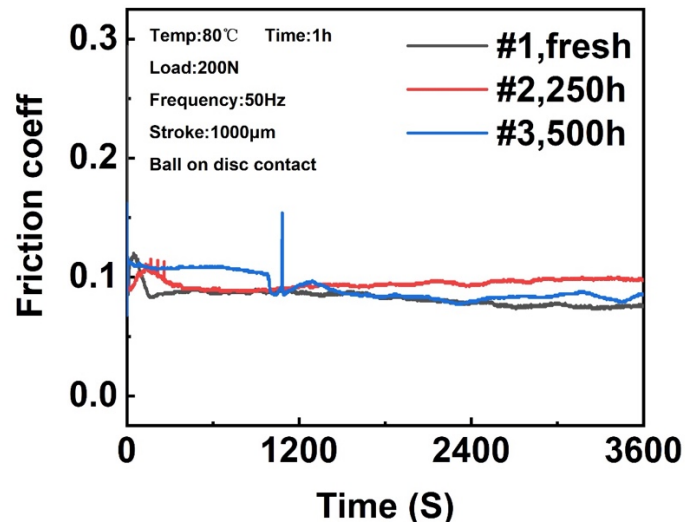
### I. SRV friction (Figure 12)

According to the above tests, we can see that the fluid shows very good performance stability, which means that the fluid can be used for a longer time.

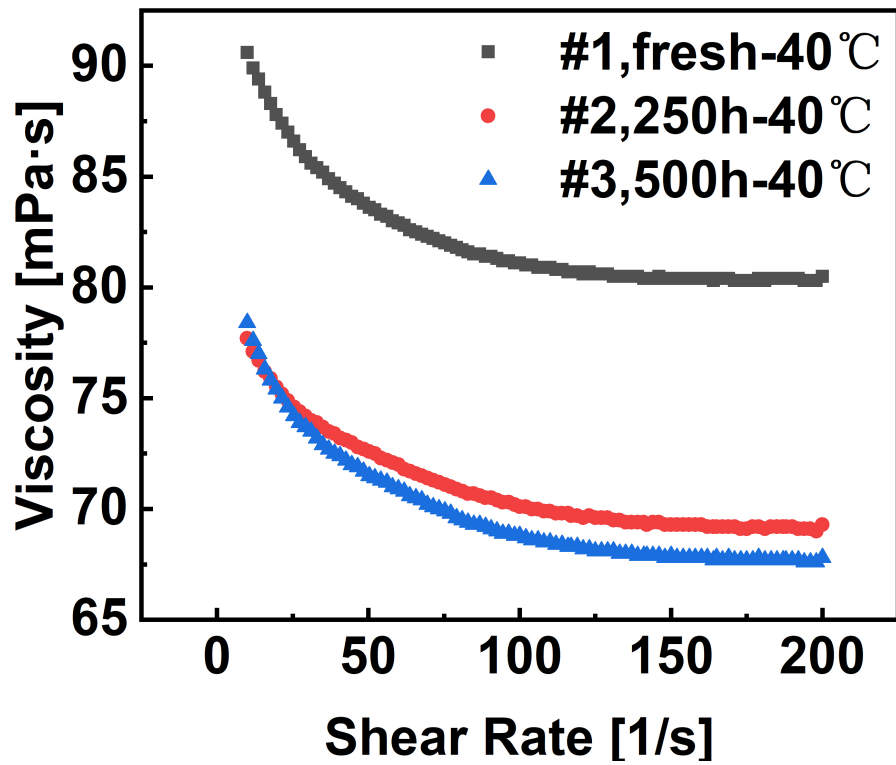
II. Rheometer (viscosity) (Figure 13)

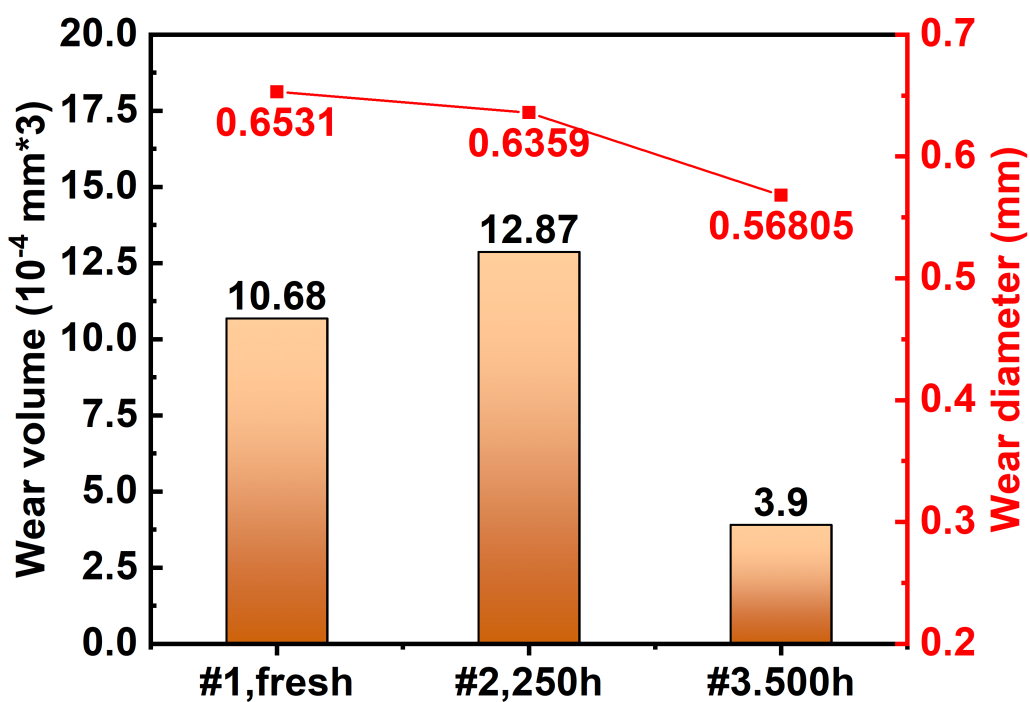
III. SRV Wear (Figure 14)

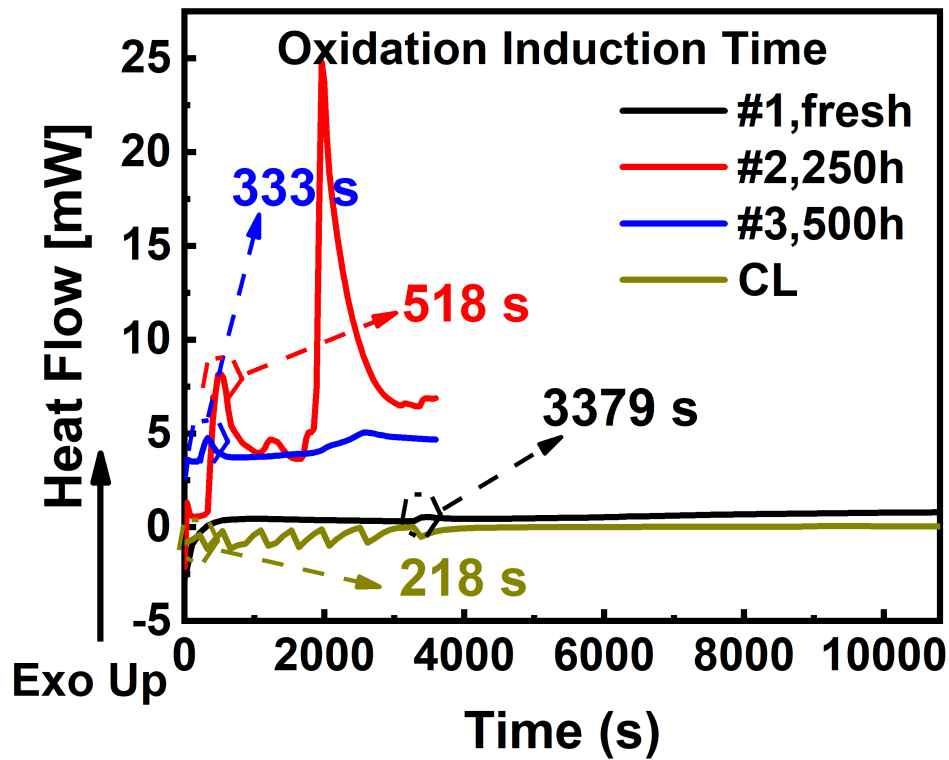
V. Antioxidation test (Figure 16)

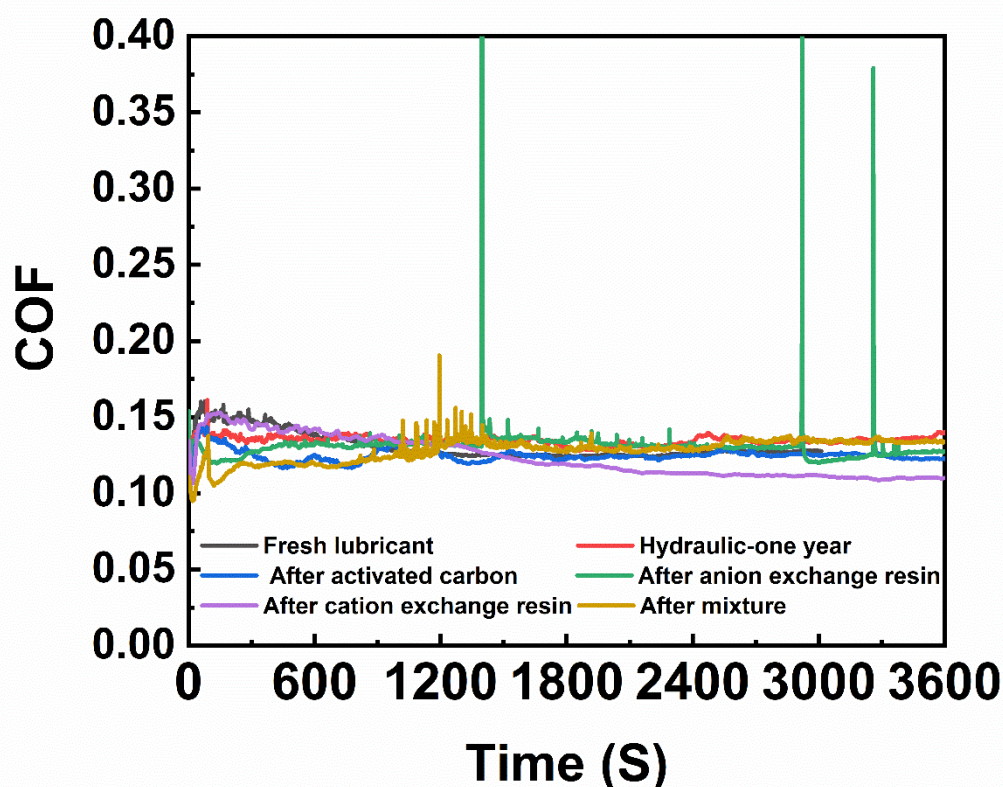
The lubrication performance of "Hydraulic-one year" waste oil decreases significantly after one year of use. This may be due to the gradual degradation and consumption of the lubricant added to the oil or the accumulation of contaminants due to long-term use, resulting in a decrease in its lubrication performance. After activated carbon treatment, the lubrication properties of waste oil were improved. This may be because activated carbon can adsorb and remove certain impurities, pollutants, and degradation products in waste oil, thereby purifying the oil and improving its lubrication performance. After anion exchange resin and mixing treatment, the lubrication performance of the waste oil was improved, but the stability was poor. Anion exchange resins may be able to remove some negatively charged ions or molecules, further purifying the waste oil. These treatment steps may help improve the lubricating properties of waste oil and reduce friction and wear of mechanical components. Finally, after treatment with cation exchange resin, the lubrication properties of the waste oil were optimal. Cation exchange resin can remove some positively charged metal ions or small molecules, further purifying the waste oil. In addition, cation exchange resin may also be able to introduce some components that are beneficial to lubrication properties, thereby improving the lubrication effect of waste oil. Blended processing combines methods to further improve the quality and performance of waste oil. At the same time, the four treatment methods mainly use the principle of adsorption. The adsorption effect reduces the viscosity of the oil and reduces friction. In summary, the lubrication properties of waste oil are improved through activated carbon, anion exchange resin and mixing treatment, while cation exchange resin treatment further improves its lubrication effect.

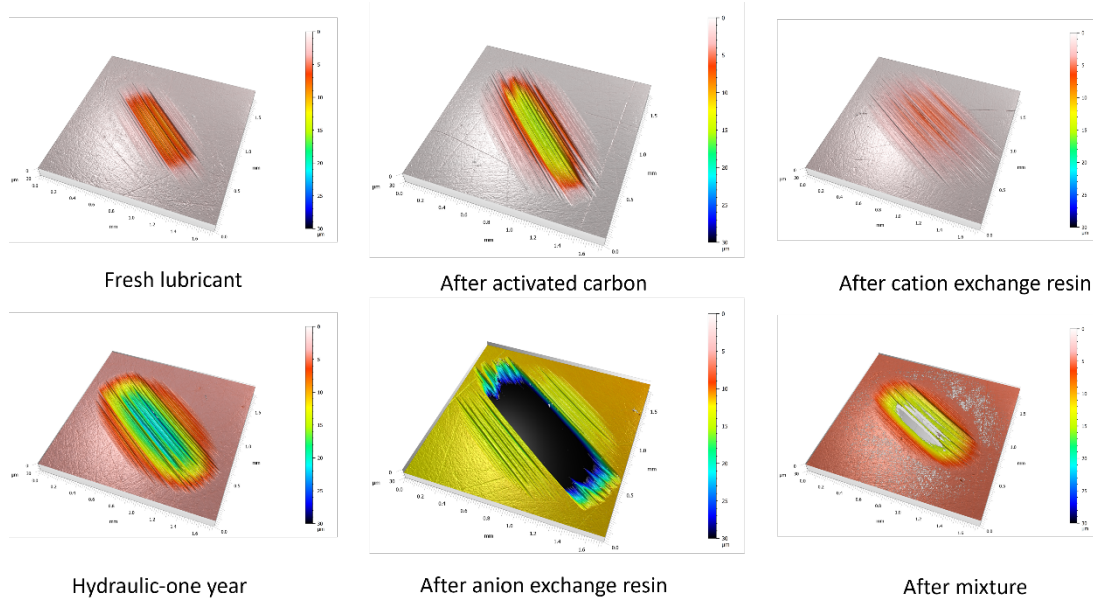
According to the figure, the anti-wear properties of waste oil changed significantly after different processing steps. The anti-wear properties of the original "Hydraulic-one year" waste oil decreased significantly after one year of use due to lubricant degradation or consumption caused by prolonged use, which increased friction and wear. After activated carbon treatment, the lubrication properties of the waste oil were improved, but the anti-wear properties were not fully restored, due to not targeting all wear mechanisms to have a significant effect. However, the anti-wear performance of waste oil after anion exchange resin and mixed treatment is worse than that of aged oil, possibly due to the removal of

some anti-wear agents during the treatment process. The anti-wear performance of waste oil treated with cation exchange resin reaches the best level, which is close to the level of fresh lubricating oil. This may be due to the successful removal of harmful components and the retention of most of the anti-wear agent components. In summary, cation exchange resin treatment is crucial to improving the anti-wear properties of waste oil, while retaining important anti-wear agent components, providing reliable technical support for the reuse of waste oil.

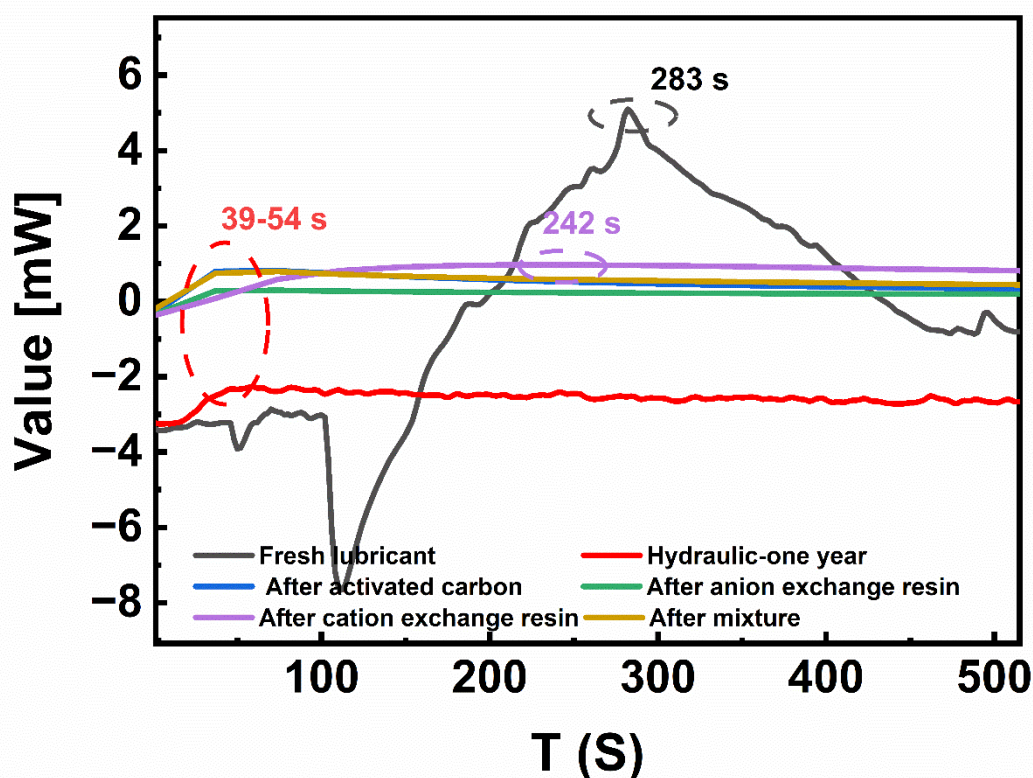
During OIT testing, changes in the antioxidant properties of waste oil were observed after different treatment steps. First, the antioxidant properties of the original "Hydraulic-one year" waste oil are significantly reduced. This may be due to the gradual degradation or consumption of the antioxidants added to the oil due to long-term use, and the introduction of new small molecules that are easily oxidized. substances, leading to a decrease in the oil's resistance to oxidation. The antioxidant performance of the waste oil that has been treated with activated carbon, anion exchange resin and mixing has not been improved, and the oxidation induction time is still in the range of 39-54 seconds. This may be because these treatments do not effectively repair the degradation or depletion of

antioxidants in the oil and do not remove small molecules prone to oxidation. However, the antioxidant performance of waste oil treated with cation exchange resin is significantly improved, approaching the level of fresh lubricating oil, and the oxidation induction time exceeds 200 seconds. This shows that the cation exchange resin successfully adsorbs and removes small molecules that are easily oxidized, improves the oil's resistance to oxidation, and makes its antioxidant performance close to the level of fresh lubricating oil. In summary, cation exchange resin treatment is an effective waste oil treatment method. It can not only improve the antioxidant properties of waste oil, but also protect or repair the antioxidants in the oil, extend its service life, and provide opportunities for reuse. Provided important technical support.

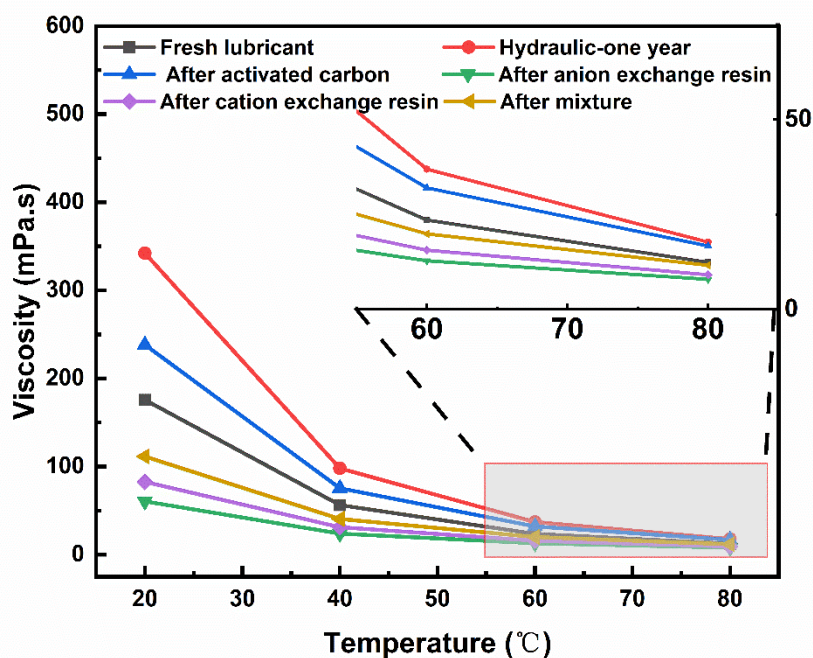
The viscosity changes of the oil after different processing steps were observed by Rheometer testing. "Hydraulic-one year" used oil has an increased viscosity compared to fresh lubricating oil. This may be due to the degradation or precipitation of certain components in the waste oil due to long-term use, increasing the viscosity of the oil. After activated carbon treatment, the viscosity of the waste oil is slightly reduced. The adsorption effect of activated carbon may help to remove some polymer compounds or sediments in the waste oil, thereby reducing the viscosity of the oil. However, the viscosity of waste oil after anion exchange resin, cation exchange resin and mixing treatment is significantly reduced and is much lower than fresh lubricating oil. This may be because these treatment methods successfully remove polymer compounds, sediments or other components that cause viscosity

to rise in the waste oil, thereby improving the fluidity of the oil.

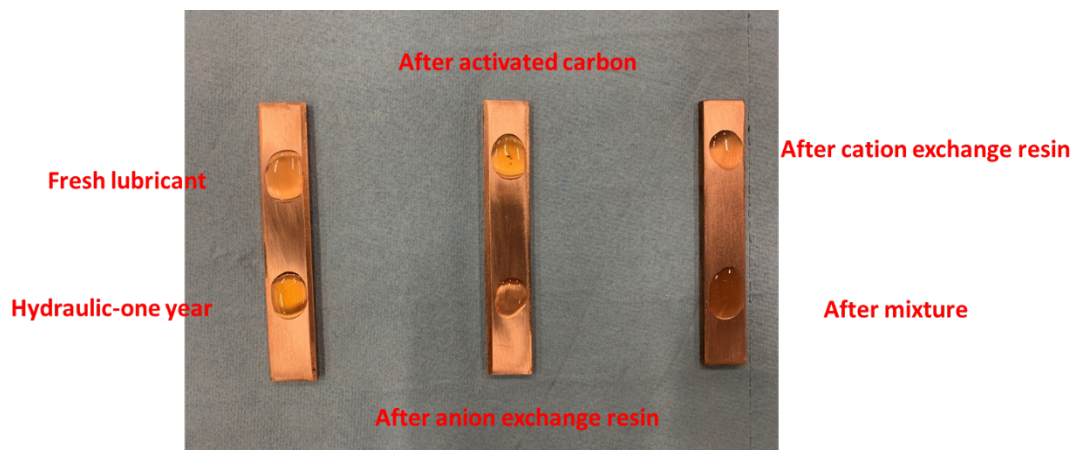
Before hotting

All oils were evaluated by the ASTM D130 standard method. In a typical copper strip corrosion experiment, a strip of freshly polished and cleaned copper was dropped with one-point lubricants at 100 °C. After 24 h, the copper strips were immediately washed with acetone and ethanol. Subsequently, these copper strips were compared with the corrosion standard tint board.

The results of copper sheet corrosion experiments conducted according to the ASTM D130 standard provide the basis for a detailed analysis of the anti-corrosion properties of oils under different treatment methods. In experiments, the copper sheet corrosion test is a commonly used method to evaluate the anti-corrosion performance of lubricating oils. By observing the effect of oil on copper corrosion, we can understand the oil's ability to protect metal parts during use. First, fresh lubricating oil, one-year-old hydraulic oil and oil treated with anion exchange resin were rated as level 3a, indicating that they have a low degree of corrosion on copper sheets under experimental conditions and have better anti-corrosion properties. These results indicate that anion exchange resin treatment may successfully remove harmful components from the oil or introduce some beneficial components, thereby improving the anti-corrosion properties of the oil. However, oils treated with activated carbon, cation exchange resin, and mixed are rated as level 3b, and their anti-corrosion properties are slightly inferior to the former. This may be due to a failure to completely remove or neutralize corrosive substances in the oil during treatment, resulting in minor corrosion. This suggests that these treatments may need further improvement to increase their effectiveness in removing harmful components and protecting metal components.

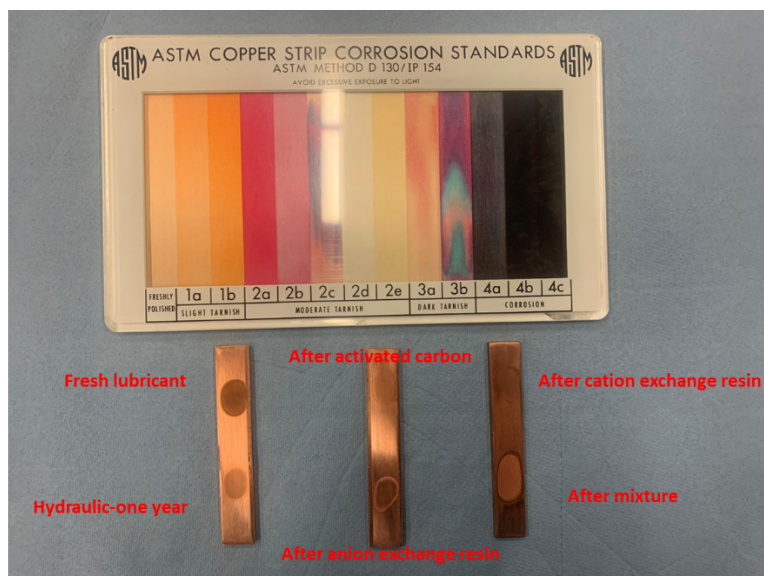
compared with the corrosion standard tint board
